AT2 Tree Surveys

Tree Condition Report for Bingham Town Council

9^h February 2019

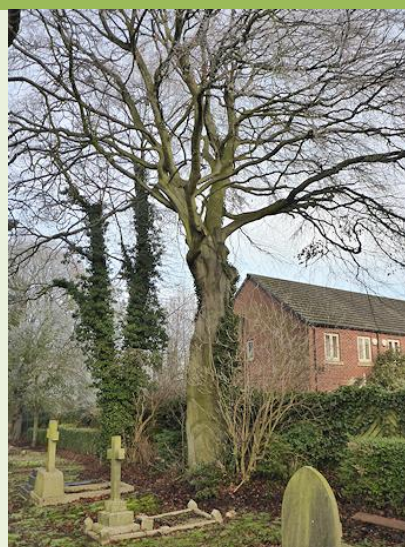
Ref.	Tree species	Works	Priority
1	Beech	<p>Large mature tree overhangs neighbouring properties. Tree has rotten fungal brackets around base that are likely to be <i>meripilus giganteus</i> (giant polypore) – see Appendix C. The canopy of the tree appears healthy but this is not a good indicator of the condition of the roots which may be weakened.</p> <p>The tree will need to be dismantled which will be complex given the proximity of gravestones below and the adjacent properties. The main stem could be retained as standing deadwood for habitat.</p>	M

Ref.	Tree species	Works	Priority	
				Decaying fungal brackets

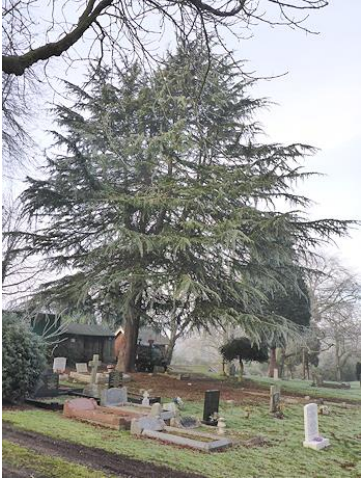
2	Cedar	Remove broken branches	L

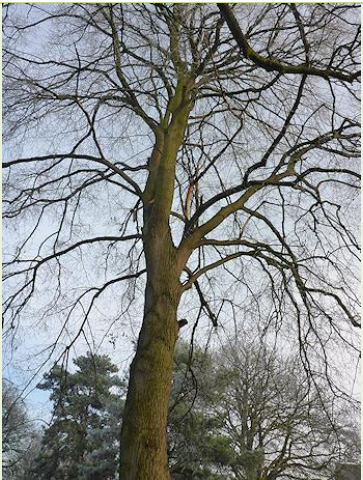
3	Lime	Remove deadwood > 25mm in diameter and more than 1 metre in length.	L

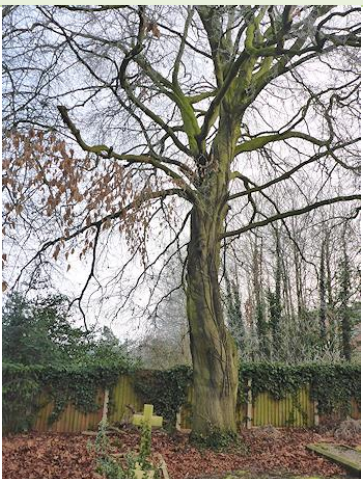
4	Beech x 2	Remove deadwood > 40mm in diameter and more than 1 metre in length.	L

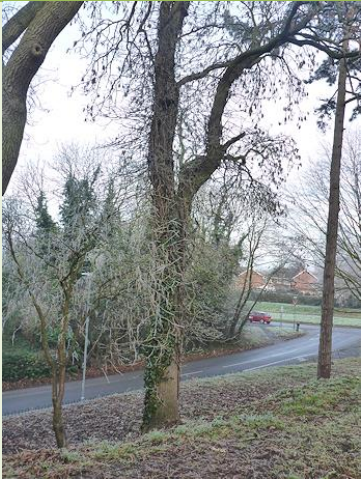
Ref.	Tree species	Works	Priority	
5	Ash	Inonotus hispidus fungal brackets in three places may lead to failure - see Appendix C. This tree is close to The Banks road and should be removed.	M

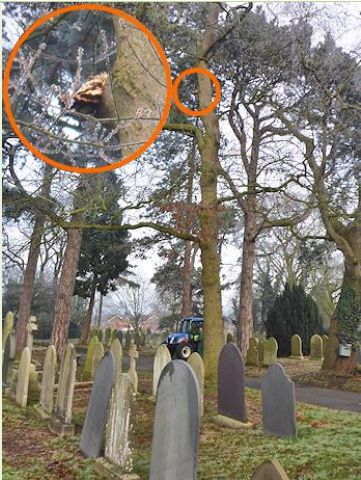
6	Red oak	Overhangs The Banks. Remove deadwood > 25mm in diameter and more than 1 metre in length.	L	
7	Red oak	Bracket fungus in old wound (Polyporus squamosus/Dryad's saddle? - see Appendix C). Decay is likely to be localised but condition of tree should be regularly reviewed.	L

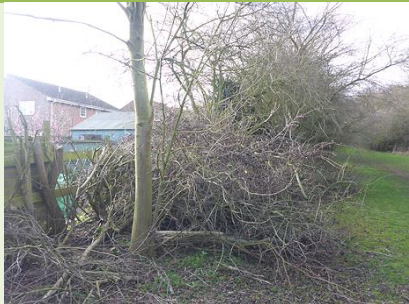
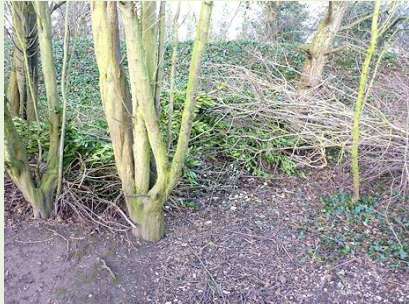
Ref.	Tree species	Works	Priority	
9	Various	Flytipping. There are several places where branches and garden waste have been cut and tipped. Neighbours may cut back overhanging branches but it is their responsibility to dispose of the arisings.	L

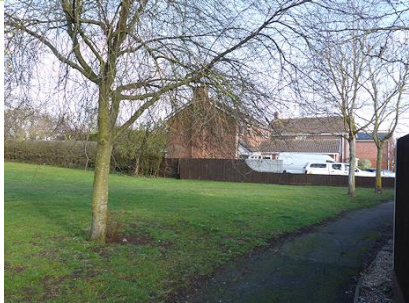
10	Cherry between Milburn Grove and Rothbury Grove	Crown lift over pavement	L

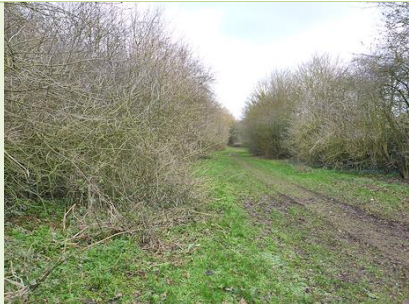
11	Various	The shrubs on either side of the path are encroaching more each year. The borders of the path should be flailed annually to constrain growth.	L

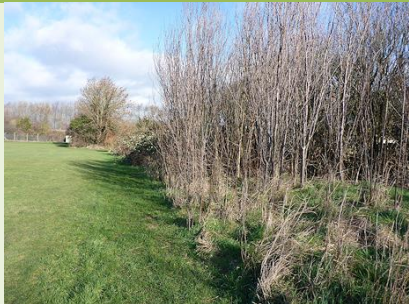
Ref.	Tree species	Works	Priority
12	Various	On the eastern boundary there are significant areas of cherry and blackthorn suckers together with bramble that have not been mown and left to grow wild. These areas could be flailed and restored with regular mowing.	L

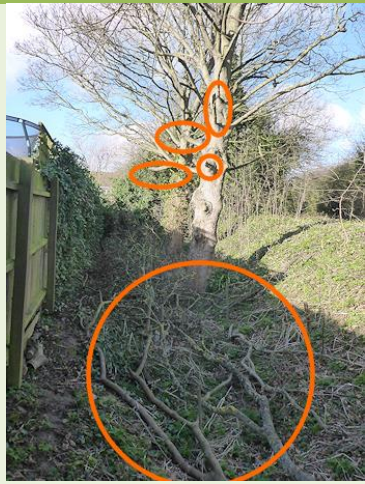
Ref.	Tree species	Works	Priority
13	Sycamores behind 5 Primrose Bank	Flytipping. Badly cut branches have been dumped. Remedial pruning required on 3 trees to correct poor cutting.	L

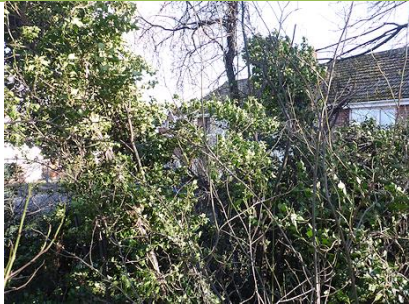
Ref.	Tree species	Works	Priority	
14	Various	"Ring" ivy to reduce wind loading in young trees on boundary with 14 Musters Road.	L

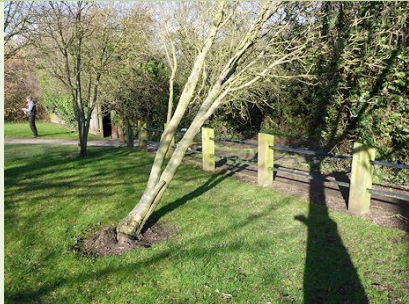
15	Rowan	Collapsed – remove.	M

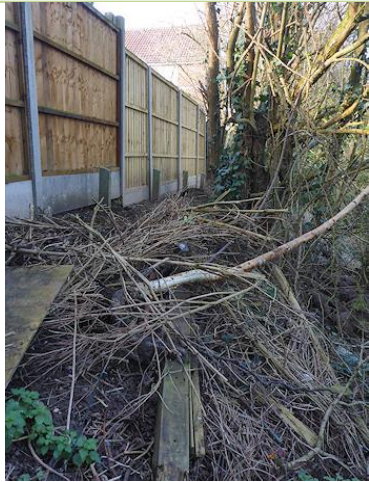
16	Flytipping	The garden in one of the cul-de-sacs off Mill Hill Road has recently been landscaped. The old turf, rubble and garden waste has been tipped down the embankment into the Linear Walk.

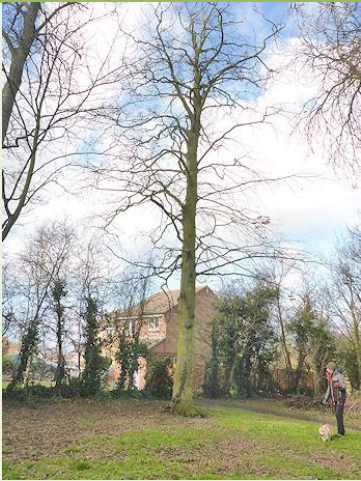
Ref.	Tree species	Works	Priority	
17	Beech	<p>Fungal brackets of <i>meripilus giganteus</i> (giant polypore) – see Appendix C were observed in the autumn. Dismantle / fell.</p> <p>Over the years there have been several trees lost from this area. Consideration should be given to planting some replacements so there are some trees for future generations to enjoy.</p>	M

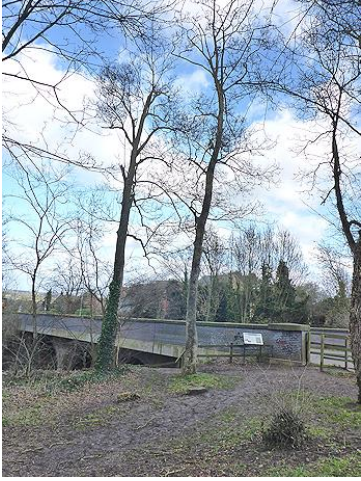
18	Sycamores x 2	<p>Declining. Deadwood has been removed in the past but the canopies continue to slowly decline and they will need removing within the next 3 years due to their proximity to Tythby Road.</p>	L

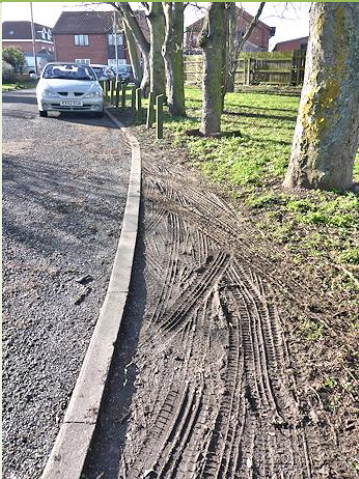
Ref.	Tree species	Works	Priority	
19	Various	Replace wooden posts to prevent vehicles parking under trees and compacting the roots.	L

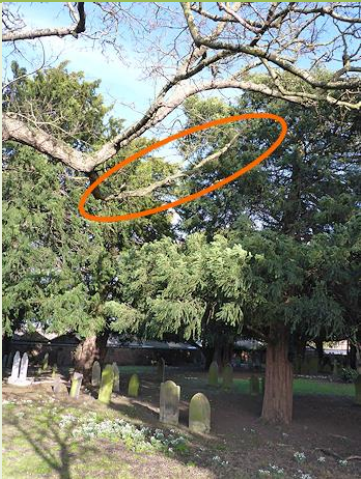
Ref.	Tree species	Works	Priority	
21	Sycamore on western boundary with footpath to railway crossing.	Remove deadwood > 25mm in diameter and more than 1 metre in length.	L

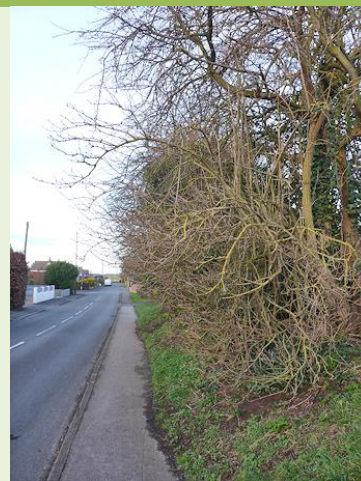
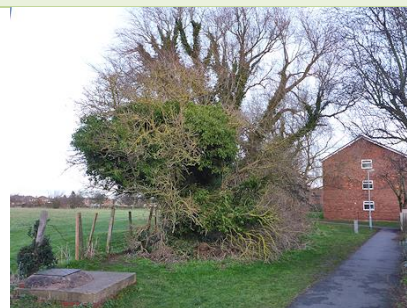
Ref.	Tree species	Works	Priority
23	Elder & hawthorn	Crown to 2.5 lift over pavement along Cogley Lane.	L
24	Willows	There is a group of willows between Crow Close and Oak Avenue where the ownership is unclear. The trees have some dead wood and willows are prone to failure in strong winds so it would be useful to establish ownership liability.

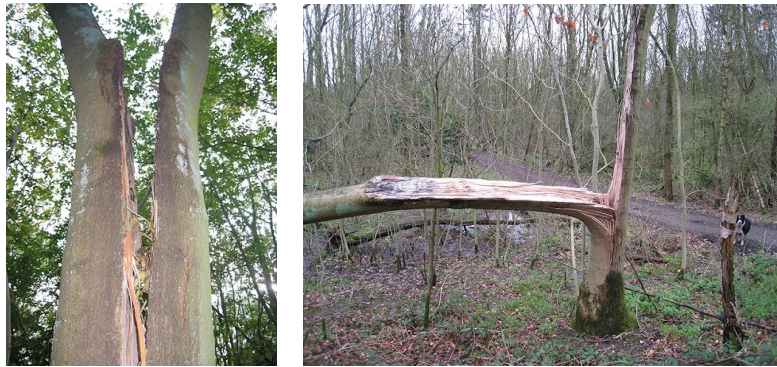
Failed ash tree with two codominant stems.
