AT2 Tree Surveys

Tree Condition Report for Bingham Town Council

9^h February 2019

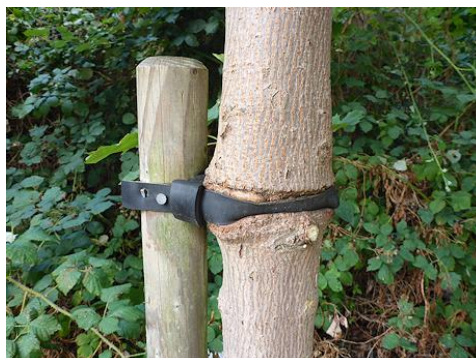
Many of the stakes and ties used to support young trees are still attached many years later. This causes two problems. As the girth of the tree grows the tie becomes embedded and can effectively strangle the tree. Also, when over-staked the tree is not encouraged to become self-supporting and so, when the stake eventually rots away, the tree loses its support and collapses. Trees should typically only be staked for the first two growing seasons. The ties should be flexible and there should be a rubber spacer block between the tree and the stake to prevent chaffing.

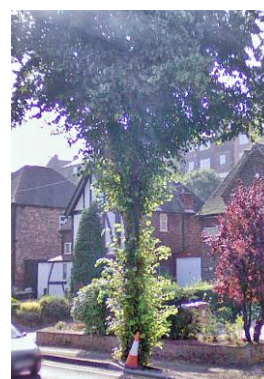
Trees such as lime and sycamore can produce bushy epicormic growth around the trunk. This does no harm but it gives a cluttered appearance and may be considered unsightly. The young growth can be safely removed to leave a clear stem. This is often carried out in conjunction with crown lifting where lower branches are pruned to raise the canopy. "Crown cleaning" is a term used for a combination of dead wooding and removal of cluttered growth.

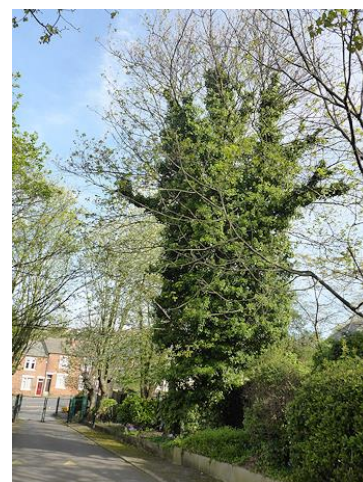
Ivy has many habitat benefits for wildlife but its presence in trees can have disadvantages. It can outcompete and overshadow weaker trees – this is common in older hawthorns. Whilst it doesn't take anything directly from the tree it does use the tree for support. Large growths can be very heavy and will increase the sail area which can lead to failure in strong winds. Ivy may also obscure other problems such as fungal brackets or areas of decay. In low risk areas it may be beneficial to retain ivy for its habitat value but in higher risk areas it should be carefully cut to leave a clear section of trunk and allowed to die back ("ringed"). Care should be taken not to cut the bark of the tree resulting in damage to the cambium layer below.

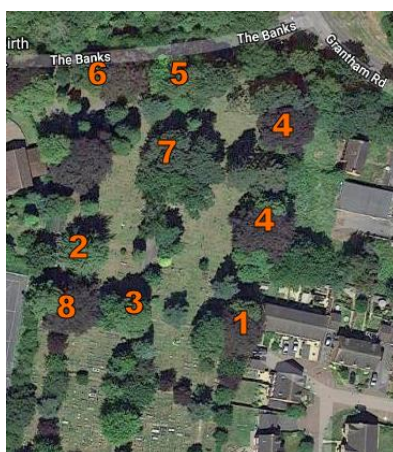
Key to tree locations at cemetery

Ref.	Tree species	Works	Priority
1	Beech	<p>Large mature tree overhangs neighbouring properties. Tree has rotten fungal brackets around base that are likely to be <i>meripilus giganteus</i> (giant polypore) – see Appendix C. The canopy of the tree appears healthy but this is not a good indicator of the condition of the roots which may be weakened.</p> <p>The tree will need to be dismantled which will be complex given the proximity of gravestones below and the adjacent properties. The main stem could be retained as standing deadwood for habitat.</p>	M
